SONOMA COUNTY AGRICULTURAL  
PRESERVATION & OPEN SPACE DISTRICT

**WRIGHT HILL RANCH  
OPEN SPACE PRESERVE  
MANAGEMENT PLAN**  
**Natural and Cultural Resources**

JANUARY 2017

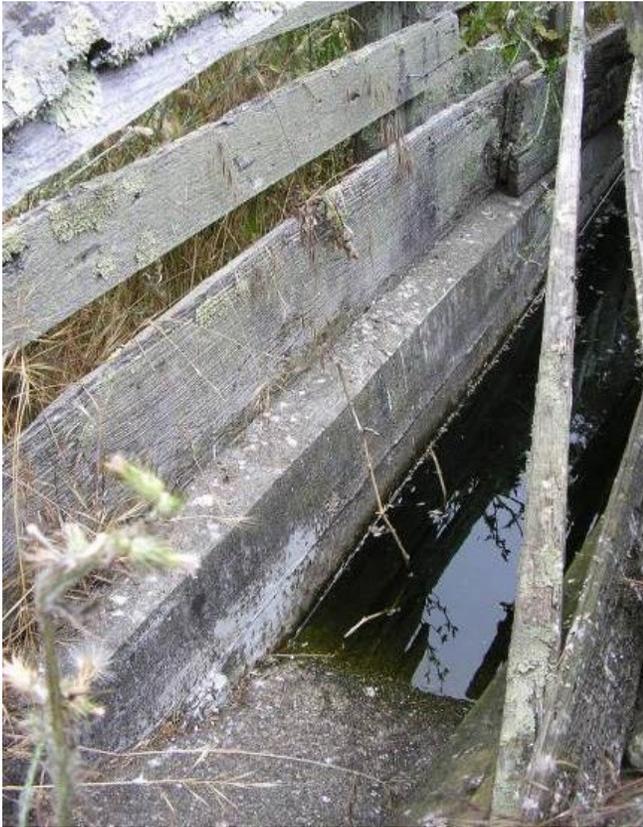
*Waste disposal site in gully*

A Phase I Environmental Assessment was prepared by Trans Tech Consultants after the property was acquired in August 2007, with the purpose “to assess the possible contamination of the project site with hazardous or toxic substances or wastes to conform to the American Society of Testing and Materials (ASTM) Standard E 1527-05 Standard Practice for Environmental Site Assessments: Phase I Environmental Site Assessment Practice” (Trans Tech Consultants 2007). The report indicated no significant environmental hazards on the property, except for an old sheep dip tank (below), which has since been remediated. A complete description of these sites can be found in the 2007 Remedial Action Plan (Trans Tech Consultants 2007).

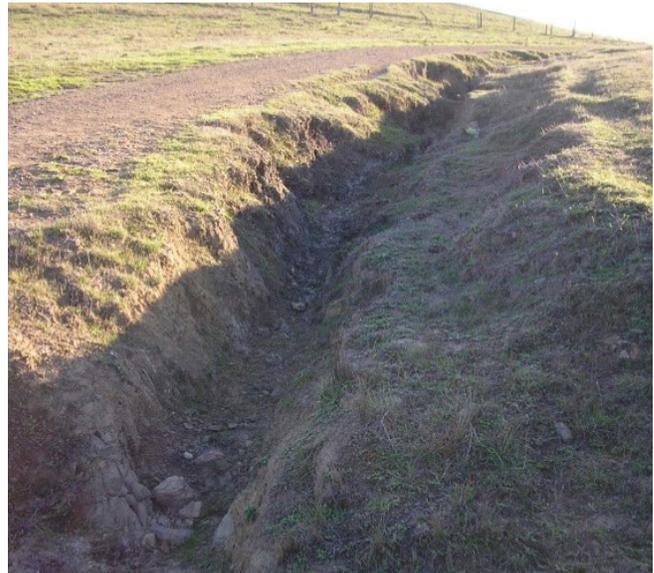
*Erosion along Wright Hill Road*

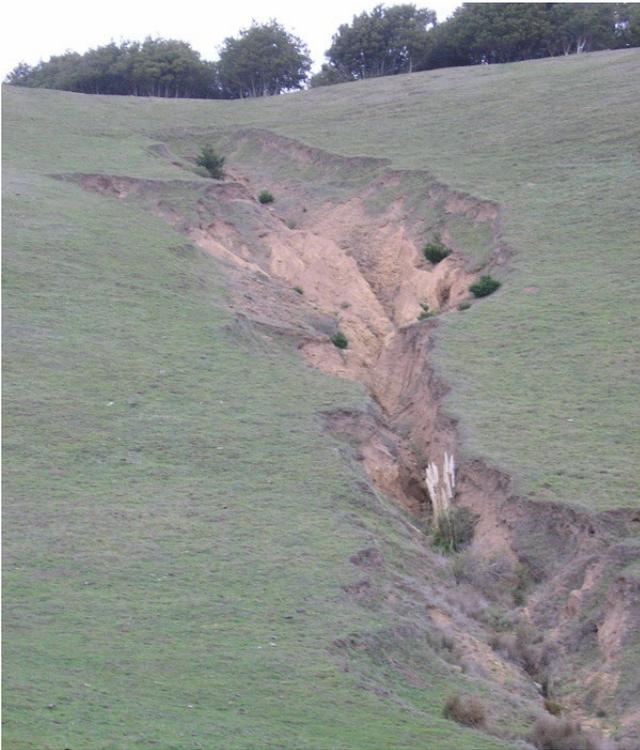
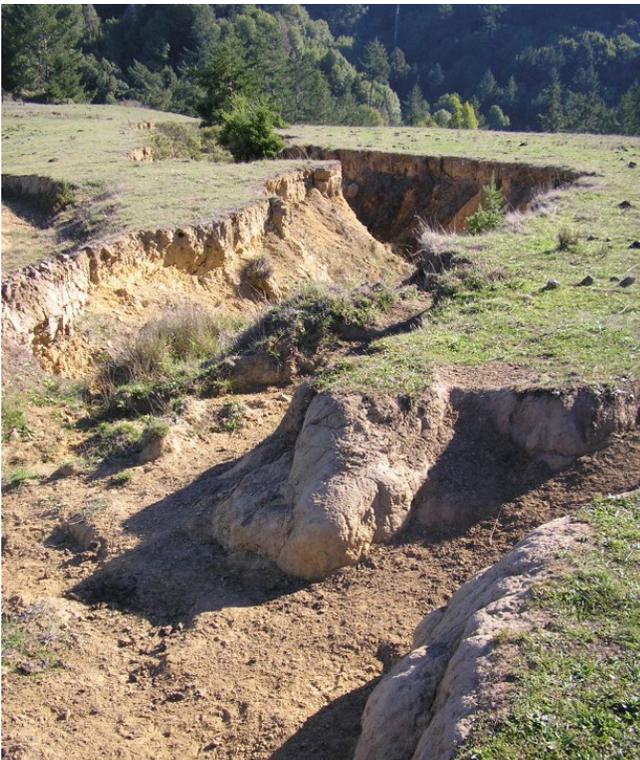
Gully erosion site #9 (top). Gully erosion site # 11 leading from Wright Hill Road (bottom).

Mapped locations, recommended treatments, and estimated costs to implement erosion control and erosion prevention treatments along the access road are described further in the complete PWA reports (PWA 2013, 2014, and 2015). See *Road Repairs and Maintenance* below for treatment schedule.

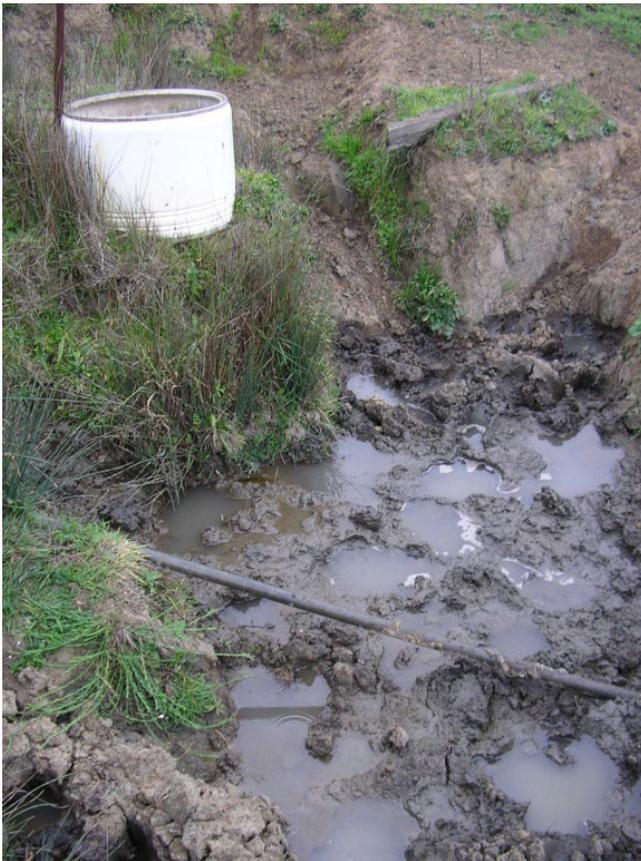
*Spring requiring repairs*

Livestock can cause or contribute to degradation of aquatic resources including riparian areas, springs, and other wetlands. Unrestricted livestock access to drainages can result in trampling and heavy grazing of vegetation, bank erosion, and water quality degradation caused by inputs of sediment, nutrients, and pathogens.

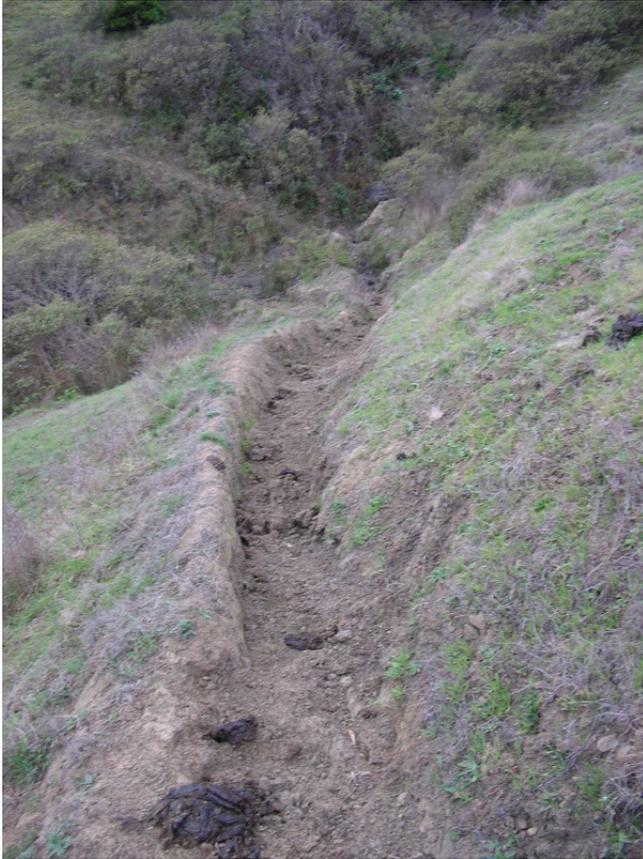
*Deeply incised cattle trail*

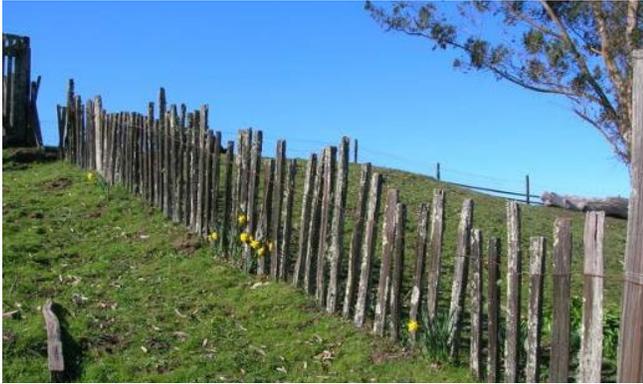
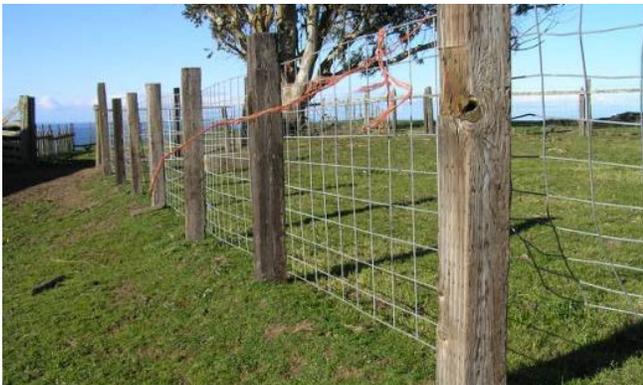
Wood picket fence (top) and woven wire fence (bottom) around the corrals and barnyards.

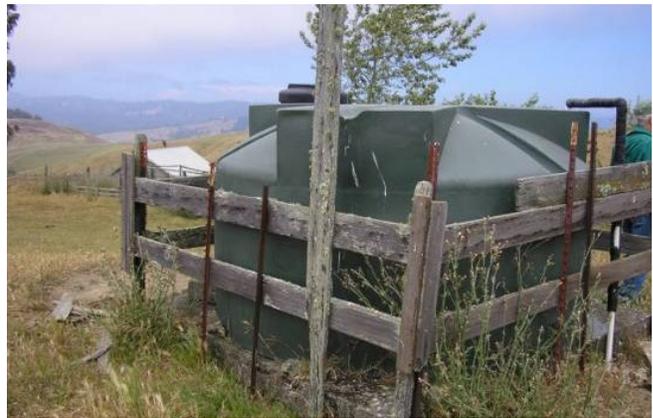
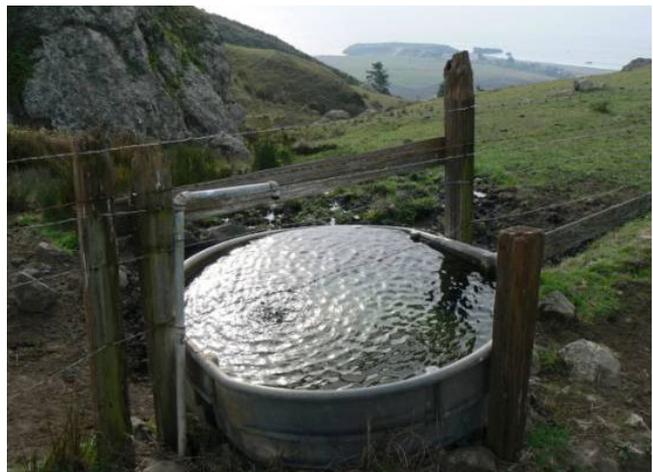
Water tank for house (top) and developed spring for livestock (bottom).

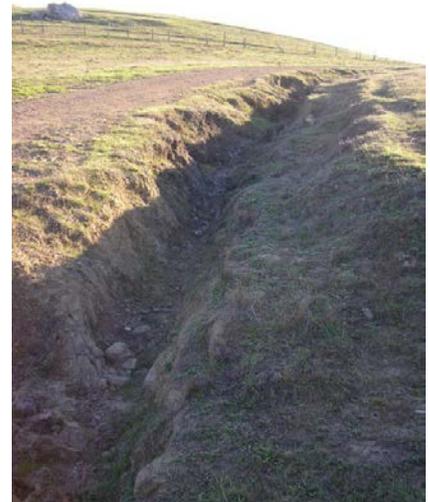
*Photopoint 92. Erosion along road.*
